West Lake Walk through - March 18, 19 & 20, 2020

West Lake Jr. Synopsis

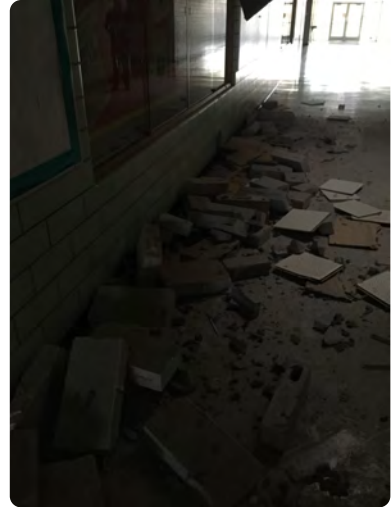
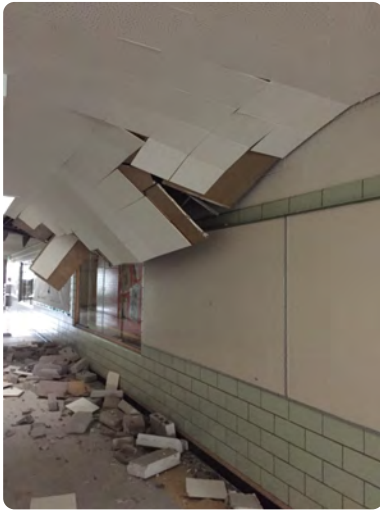
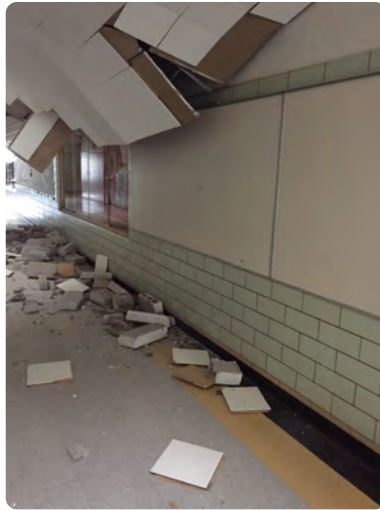
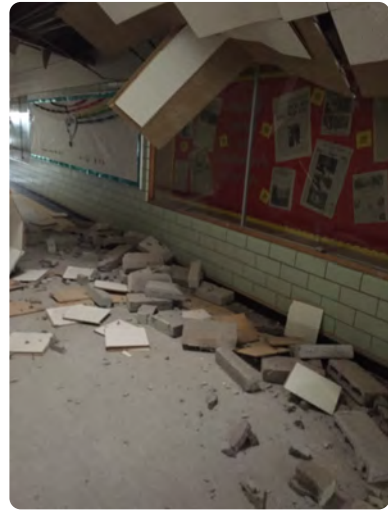
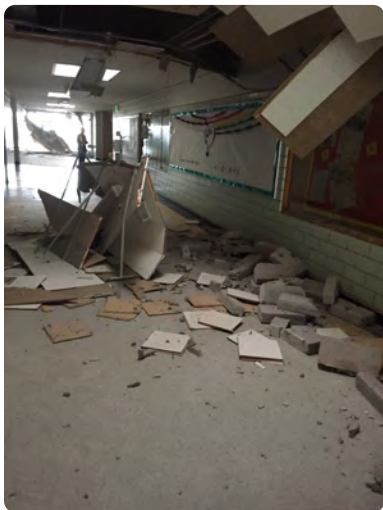
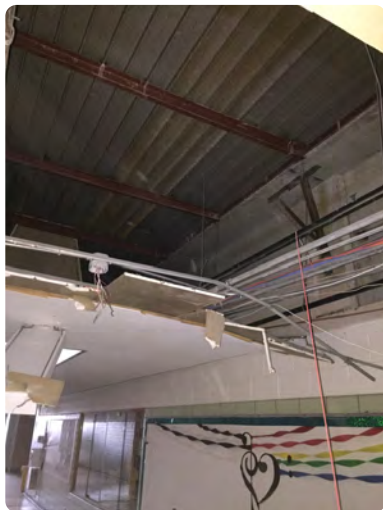
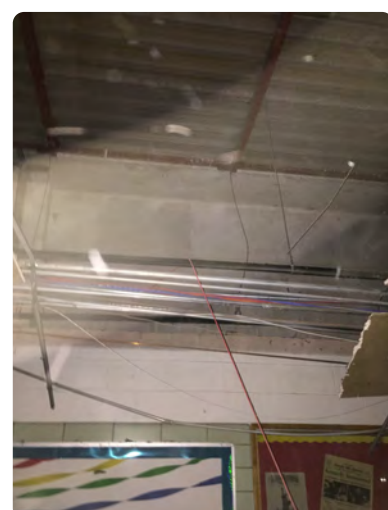
CEILING COLLAPSE

COLLAPSE IN CENTER (NORTH/SOUTH)
OF HALLWAY

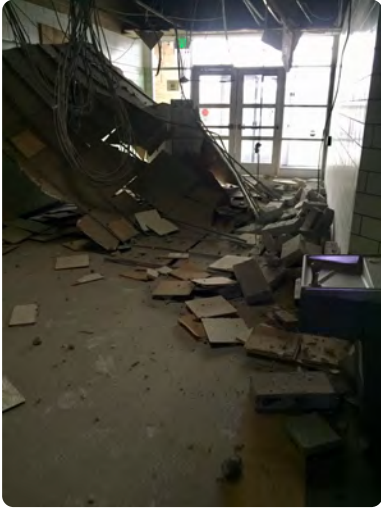
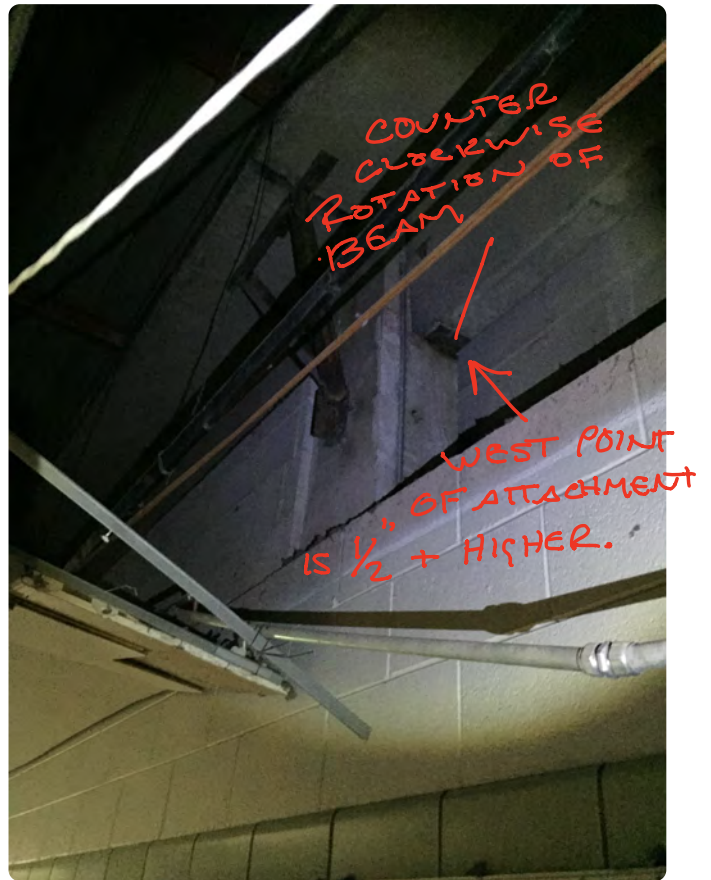
COLLAPSE @ SOUTH END OF HALLWAY

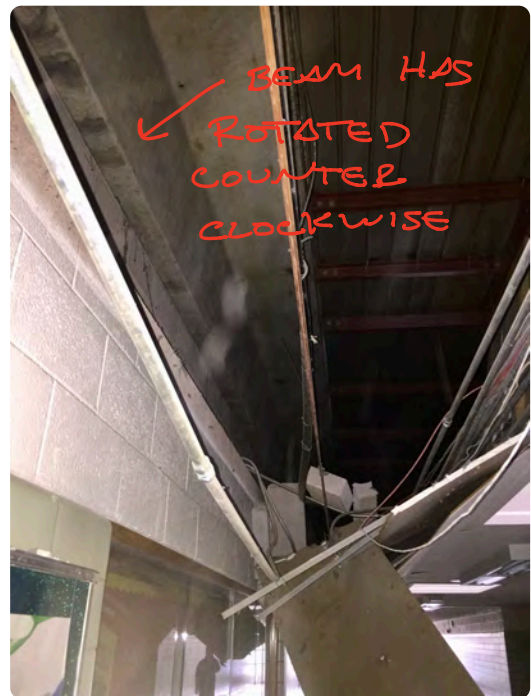
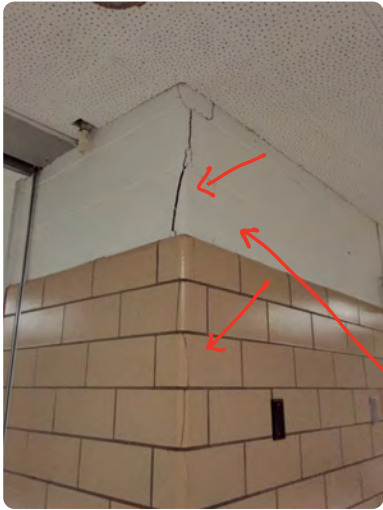
COLLAPSE @ NORTH END OF HALLWAY

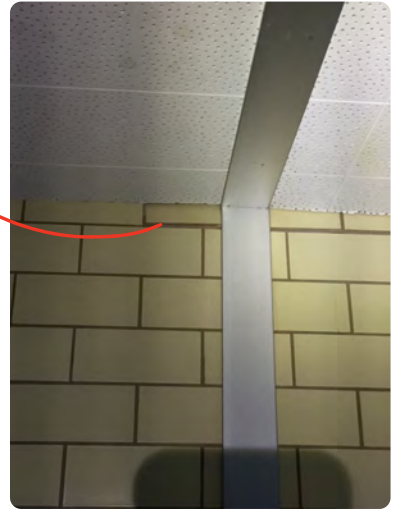
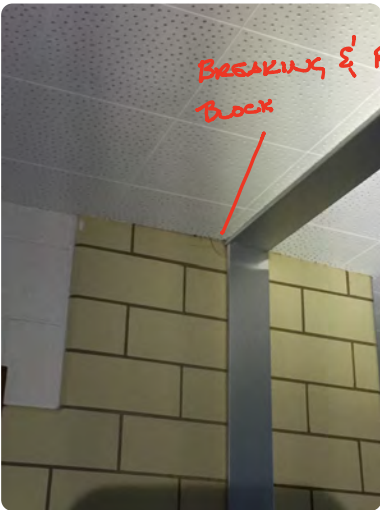
BLOCK BREAKING
& ROTATING NEAR
EXPANSION JOINT

STRESS
CRACKS IN FASCIA WALL
OVER STRUCTURAL COLUMN

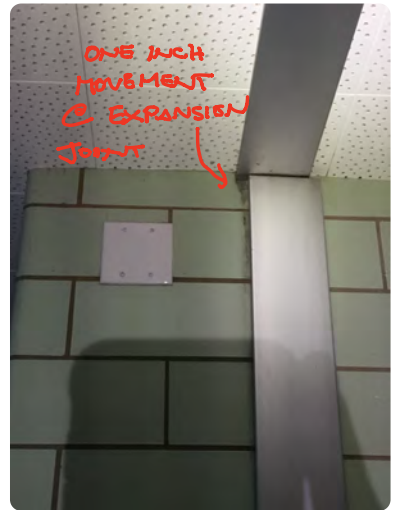
BREAKING & ROTATING
BLOCK

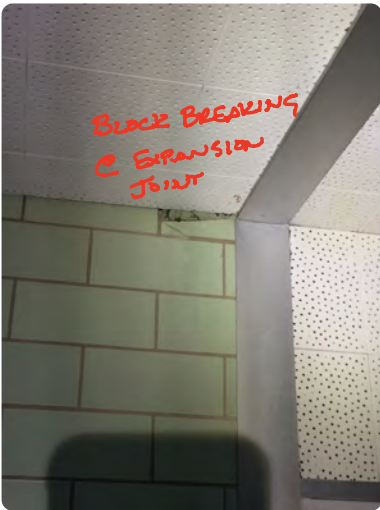
ONE INCH
MOVEMENT
@ EXPANSION
JOINT

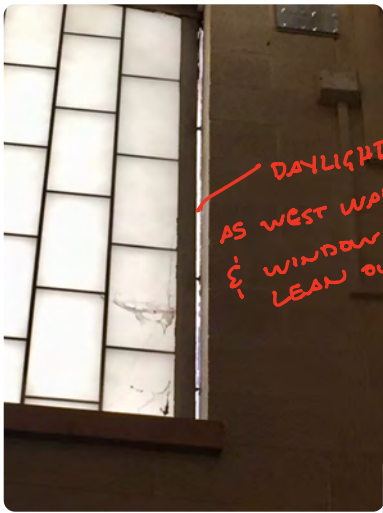
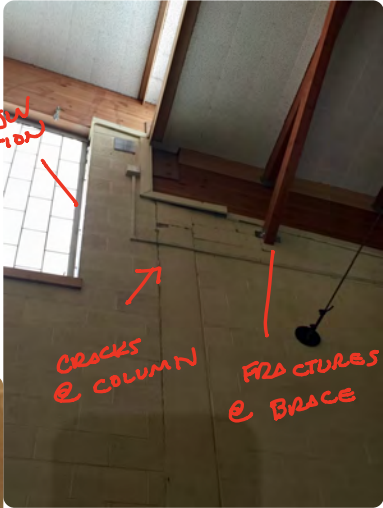
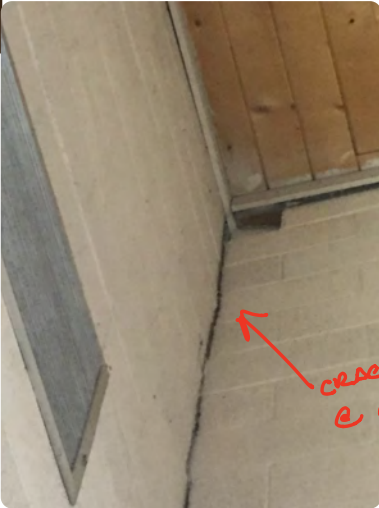
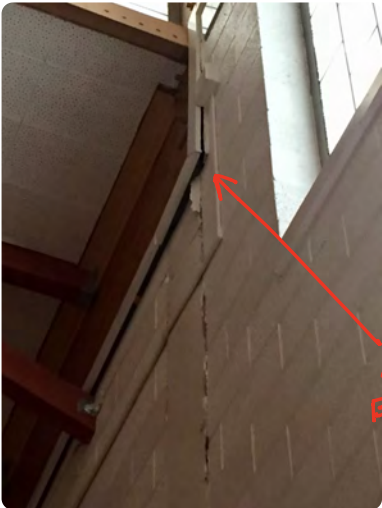
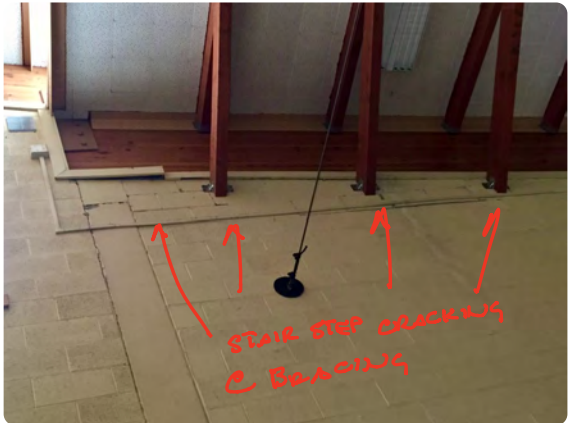
BLOCK BREAKING
@ EXPANSION
JOINT

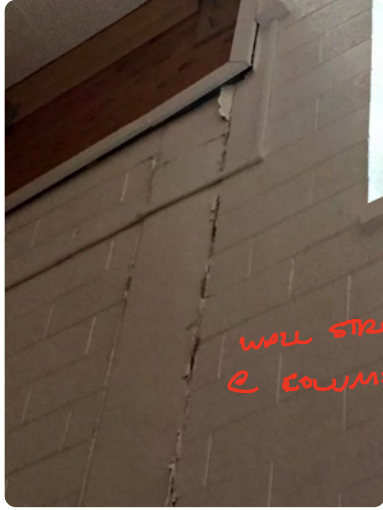
WALL STRESS/CRACKING @ COLUMN

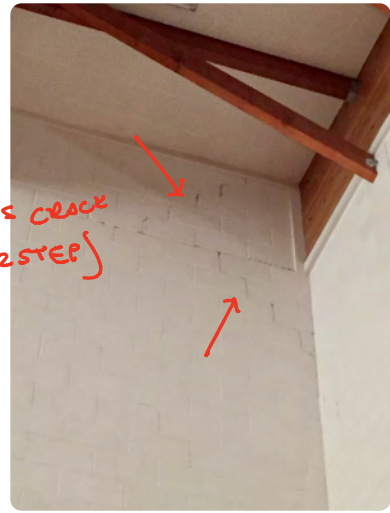
STRESS CRACK (STAIRSTEP)

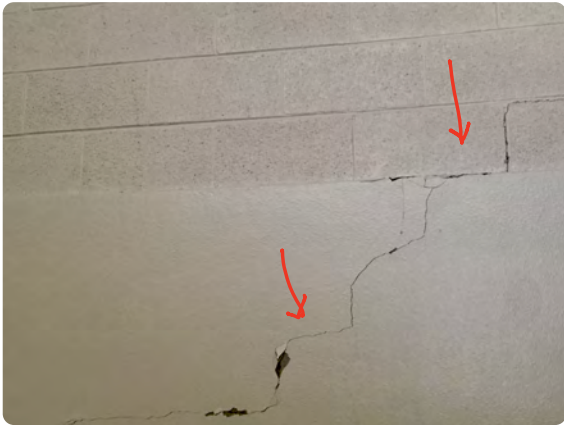
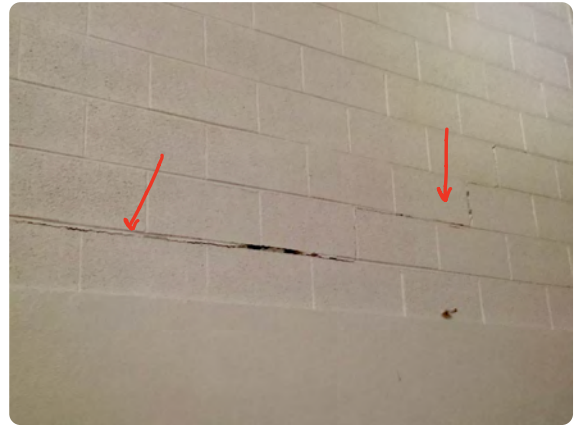
STAIR STEP CRACKS ON WALL DIVIDING MAIN GYM FROM DANCE ROOM/WRESTLING ROOM & EXERCISE ROOM.

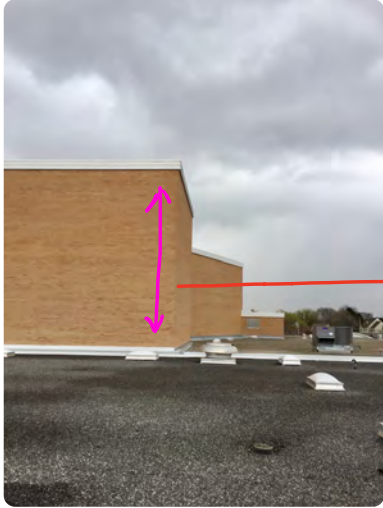
CRACKING @

SW CORNER
OF FLY LOFT

CRACKS ALSO
ON INTERIOR
BLOCK

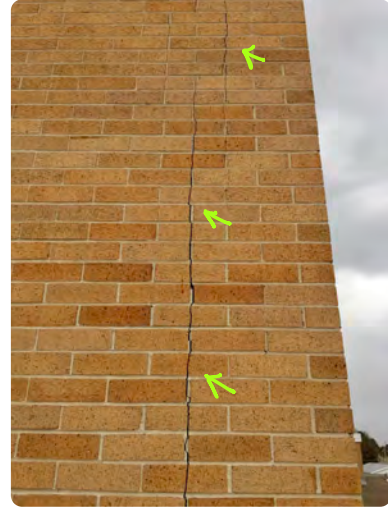
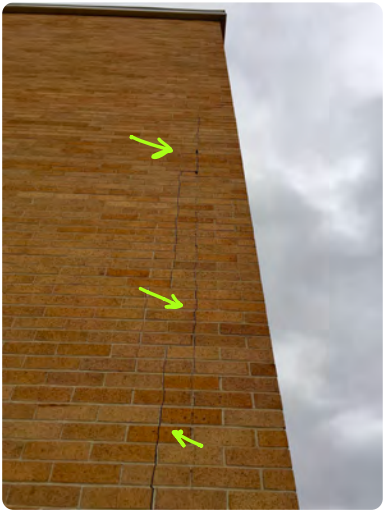
Fly loft shows cracking interior and exterior

CRACKS APPEAR
TO EXTEND FROM
BOTTOM TO TOP OF
BOTH SW & NW
CORNERS OF FLY LOFT
SW CORNER IS
MORE SEVERE

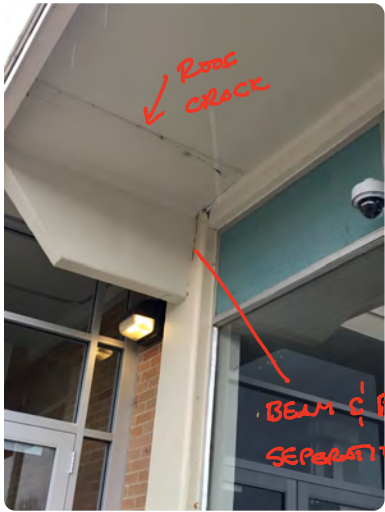
ROOF CRACK

BEAM & POCKET SEPARATION

SOUTH WEST CORNER OF STERIUM

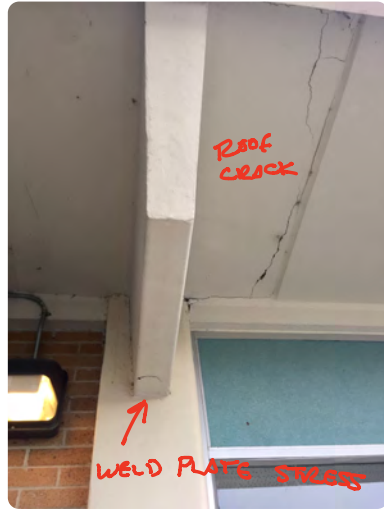
ROOF CRACK

WELD PLATE STEELS

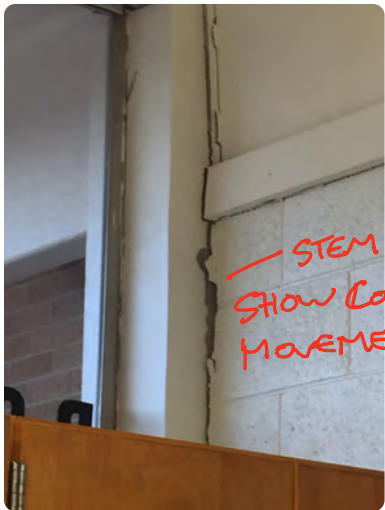
STEM LABS SHOW COLUMN MOVEMENT

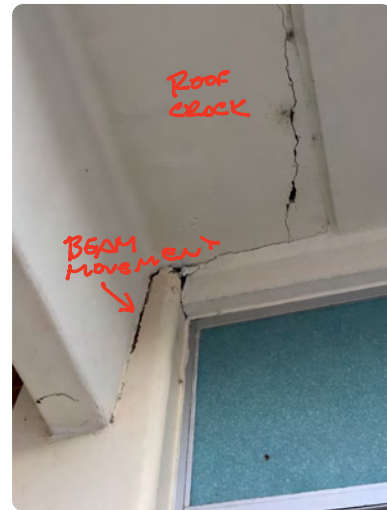
ROOF CRACK

BEAM MOVEMENT

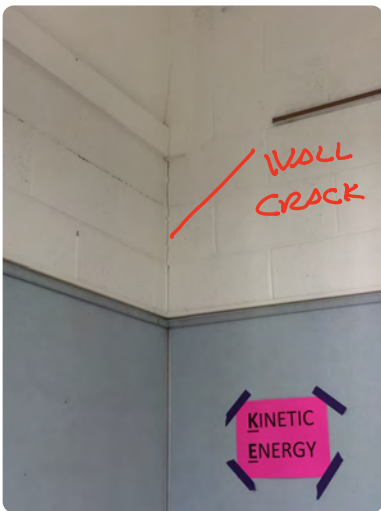
WALL CRACK

KINETIC ENERGY

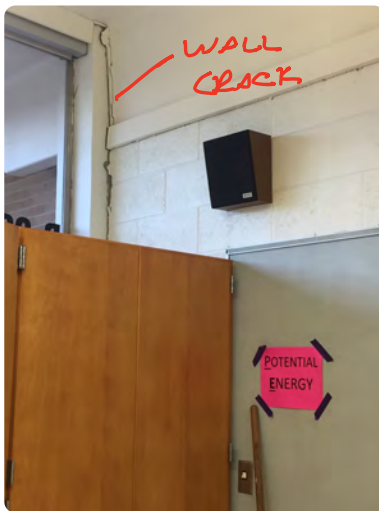
WALL CRACK

POTENTIAL ENERGY

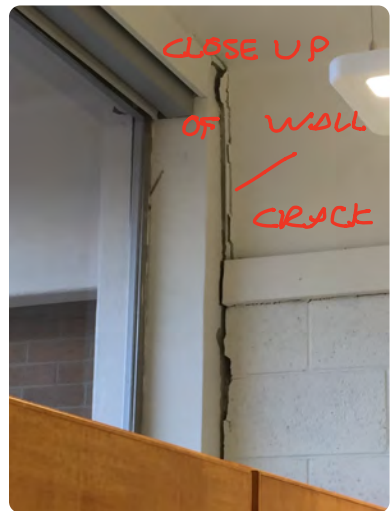
CLOSE UP OF WALL CRACK

POTENTIAL ENERGY

WALL CRACKS ON EAST WEST RUNNING INTERIOR WALLS
& ALSO ON INTERIOR CLASSROOM/HALLWAY DEMISING WALLS

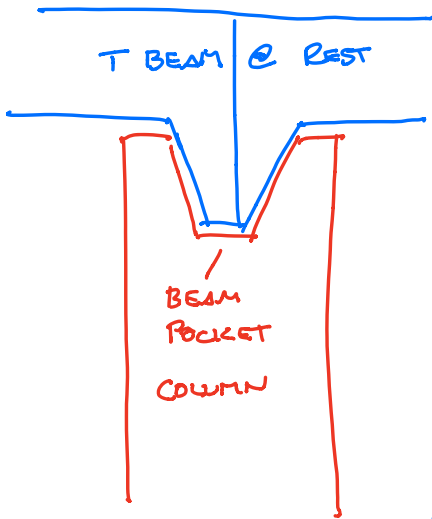
Ceiling collapsed due to beam rotation and un-reinforced block movement (all walls interior are similar construction and susceptible to such movement and shaking.

T-BEAM ROTATION CAUSING
CEILING COLLAPSE

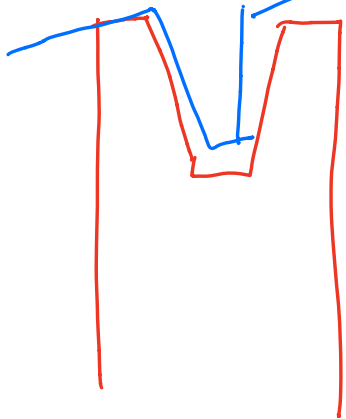
T. MOVEMENT
CAUSES 4" BLOCK
TO COLLAPSE

CEILING IN COLLAPSE
