West Lake Walk through - March 18, 19 & 20, 2020

West Lake Jr. Synopsis

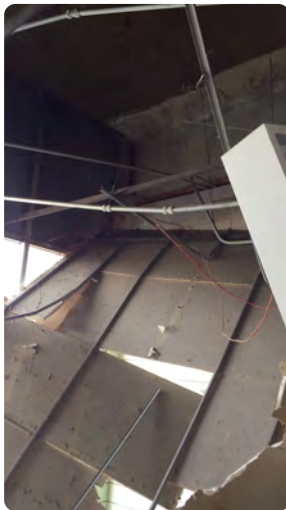
COLLAPSE @ NORTH END OF HALLWAY

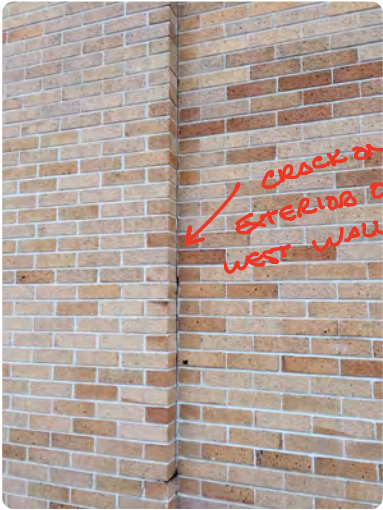
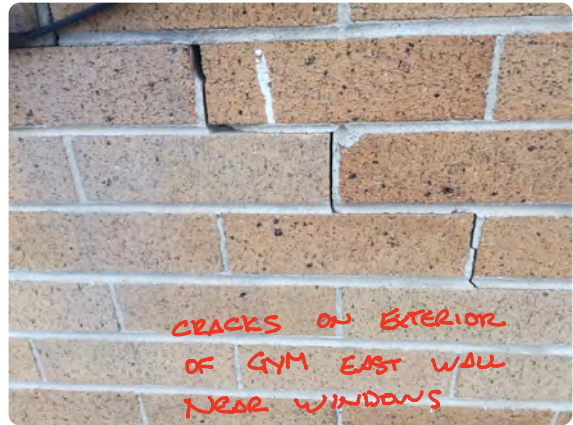
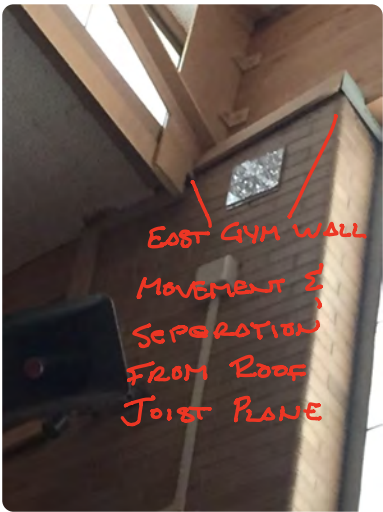
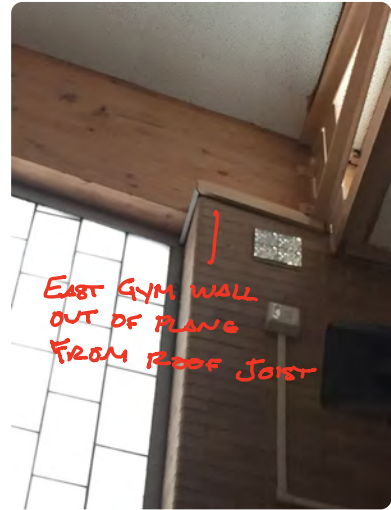
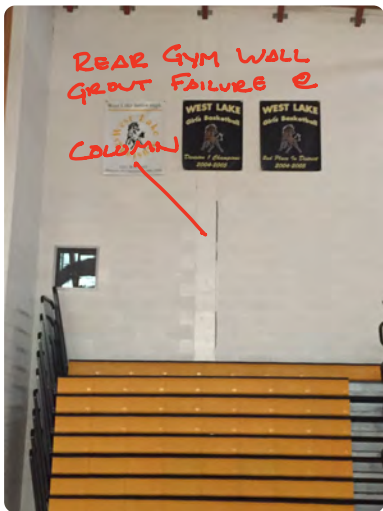
CRACKS APPEAR
TO EXTEND FROM
BOTTOM TO TOP OF
BOTH SW & NW
CORNERS OF FLY LOFT
SW CORNER IS
MORE SEVERE

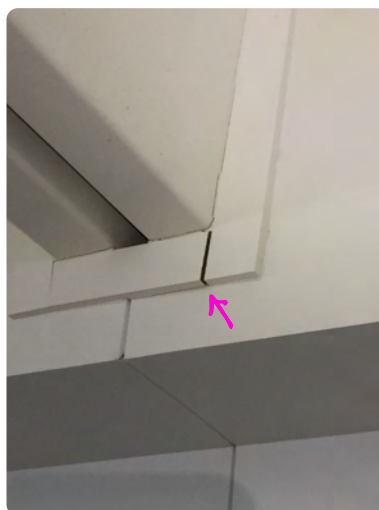
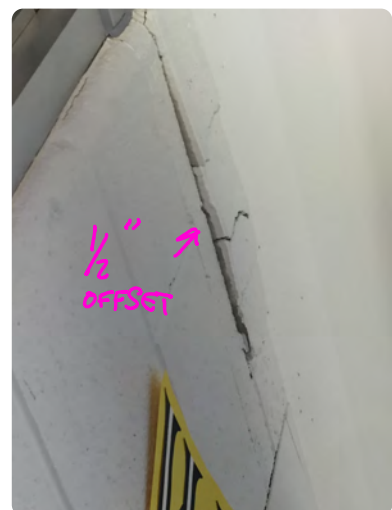
WALL CRACKS ON EAST WEST RUNNING INTERIOR WALLS
& ALSO ON INTERIOR CLASSROOM/HALLWAY DEMISING WALLS

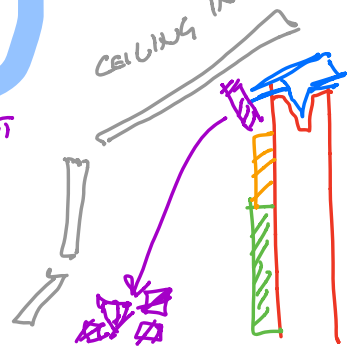
T. MOVEMENT
CAUSES 4" BLOCK
TO COLLAPSE

CEILING IN COLLAPSE
